REHABILITATION ASSESSMENT REPORT

New Creek Watershed Site 1

Mineral County, West Virginia

March 2011

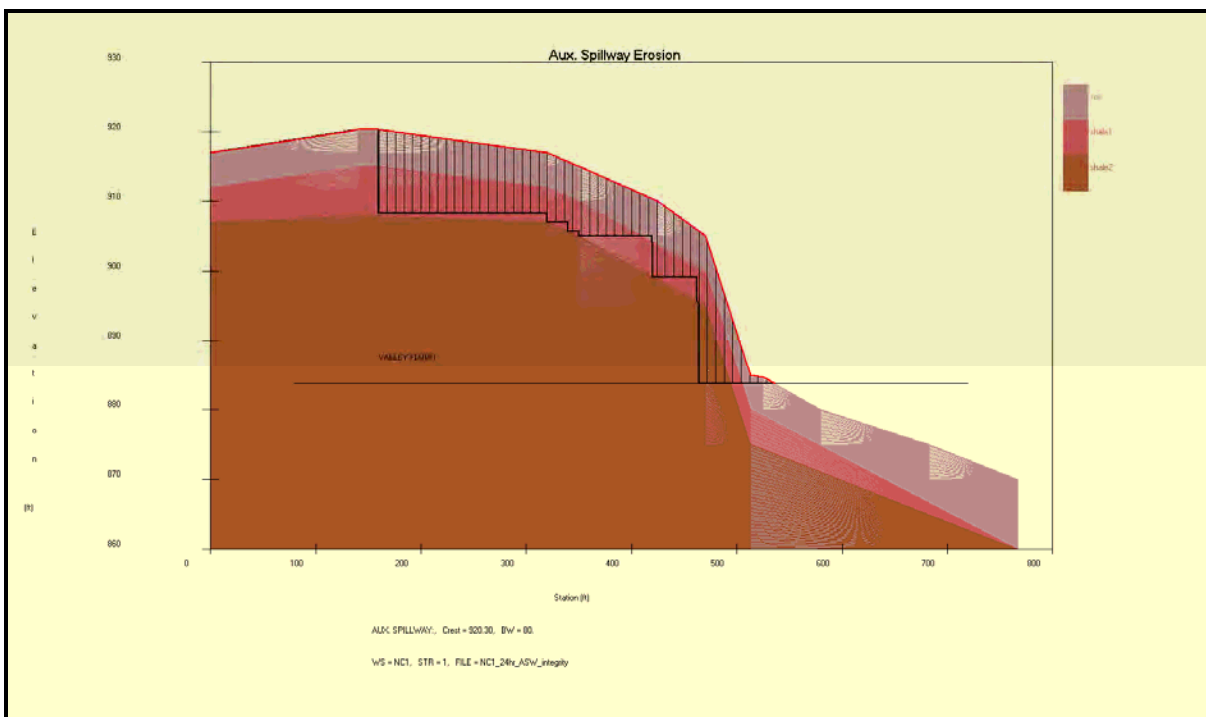
The SITES auxiliary spillway analysis shows that the auxiliary spillway will experience significant damage of the spillway during passage of the 24-hour FBH. Damage includes a headcut over 10 feet deep propagating up to the level control section of the spillway. For the 6-hour storm, the analysis shows damage of the auxiliary spillway to a lesser degree than the 24-hour storm.

Figure 3. Plot of Auxiliary Spillway Profile and Extent of Erosion from Integrity Analysis for 24-hour Class C Freeboard Hydrograph (PMF) Obtained from SITES Model Output

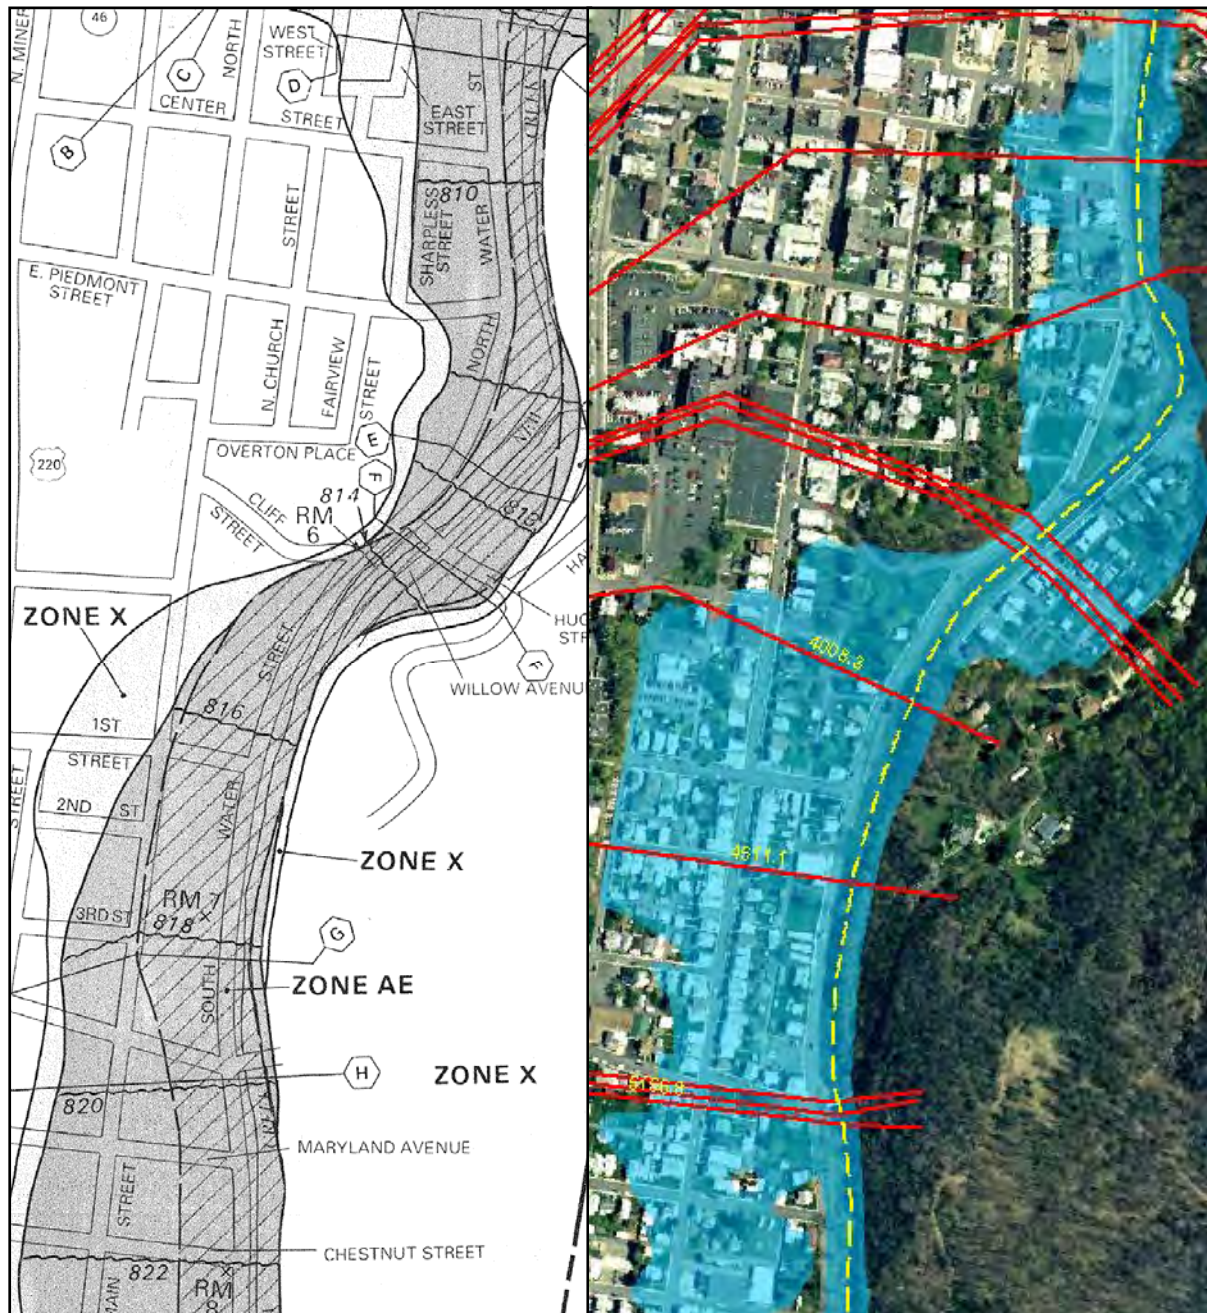
Figure 4. Side by Side Comparison of Floodplain Boundaries from the 1991 FEMA Flood Insurance Study (left) and the 2011 Gannett Fleming Dam Breach Study (right) at Keyser, WV.

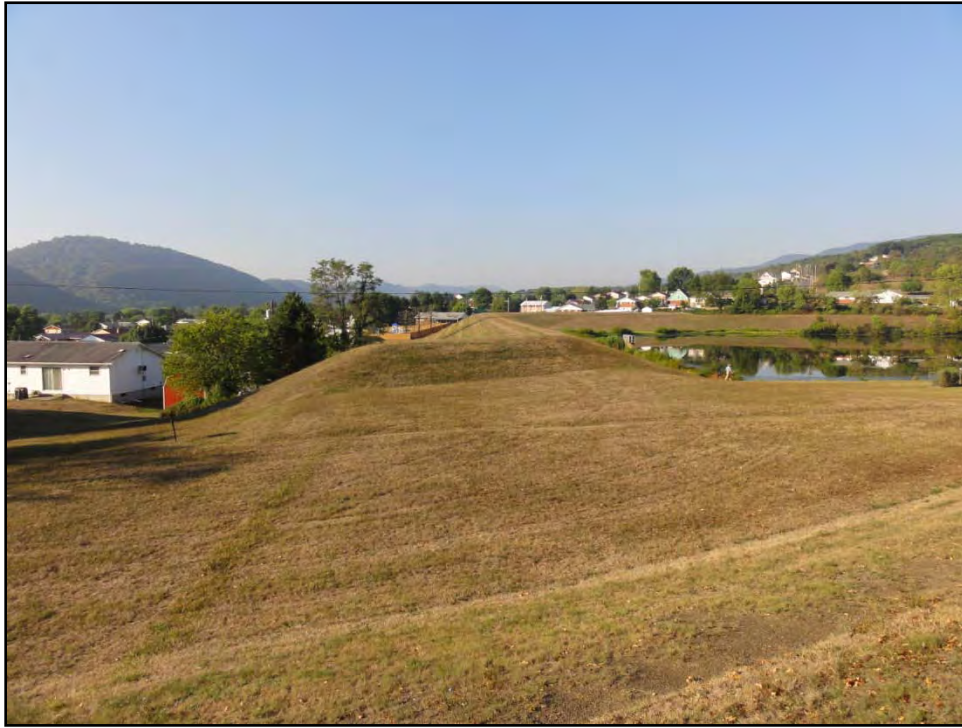
1. General overview of dam from left side of auxiliary spillway.

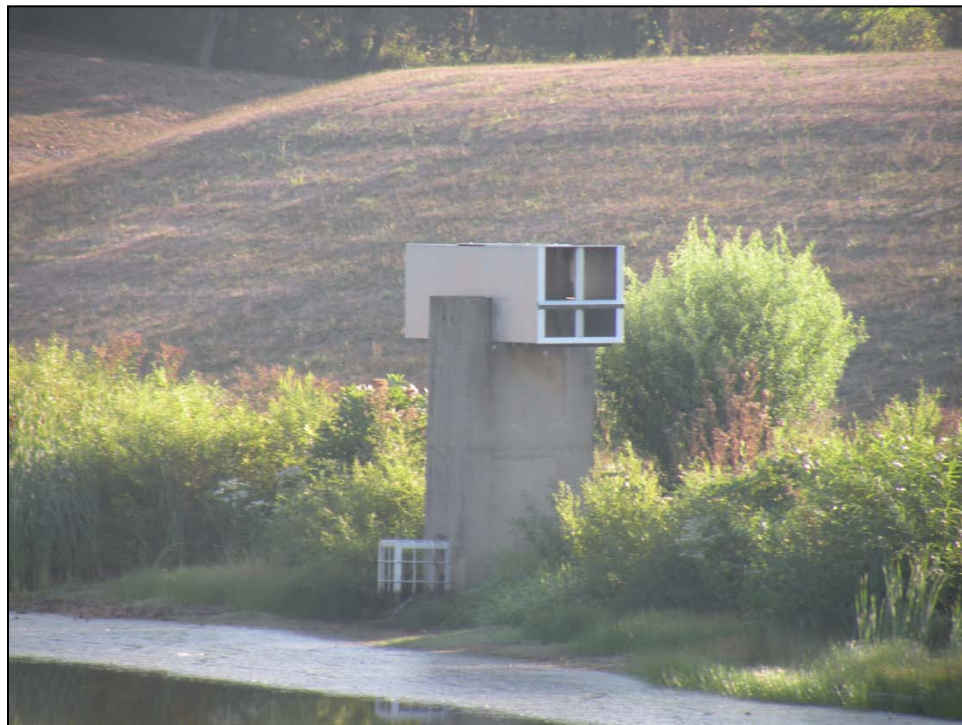
2. Principal spillway riser structure.

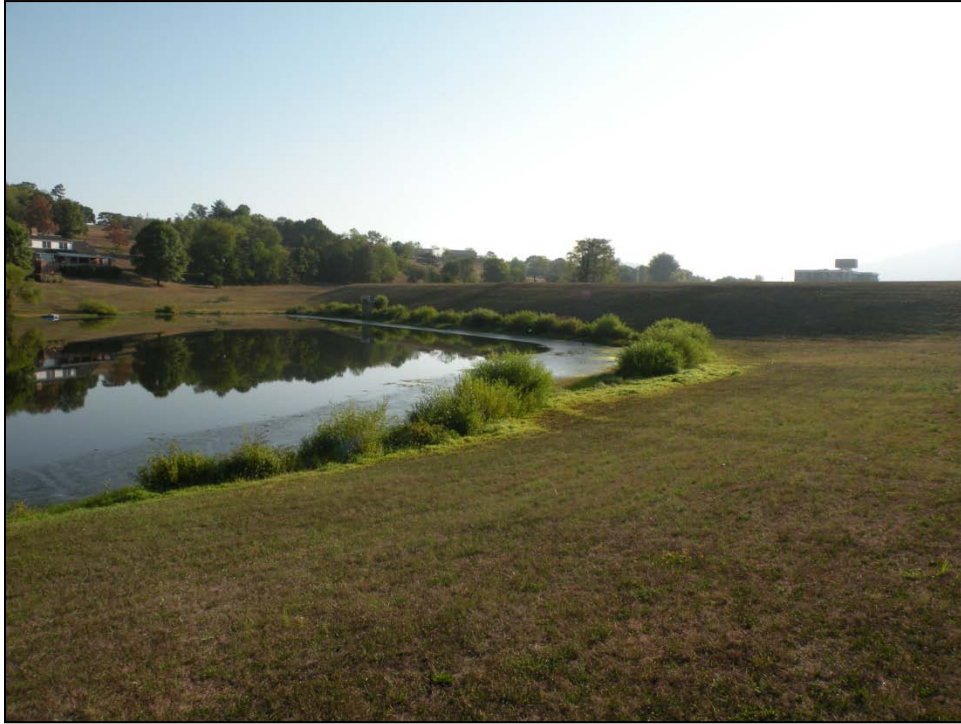
3. Upstream embankment slope.

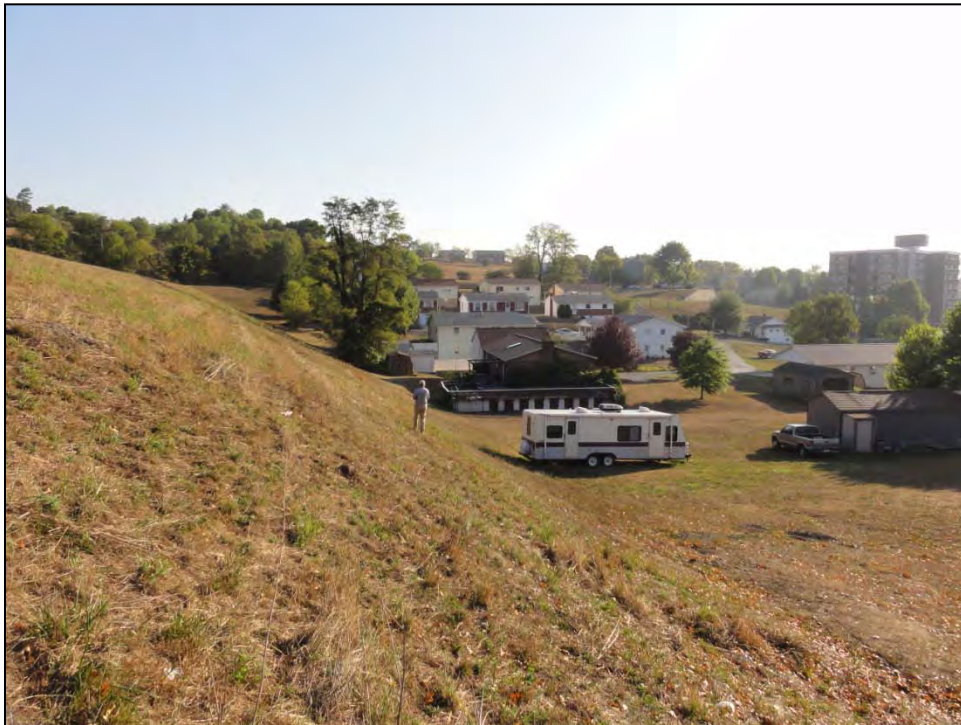
4. Downstream embankment slope.

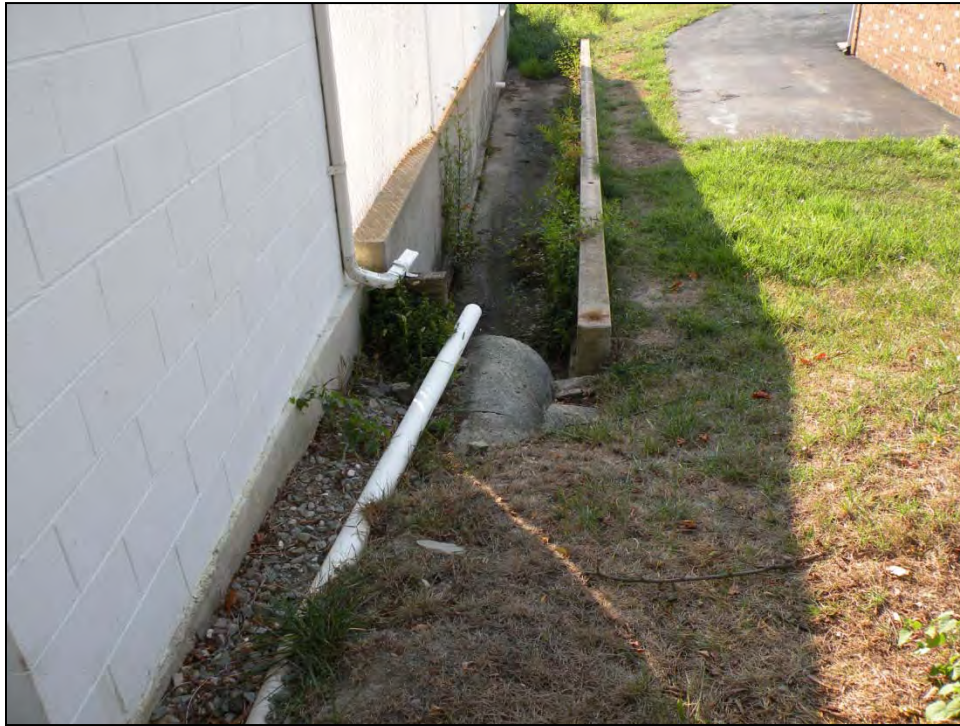
5. Outlet conduit and discharge channel.

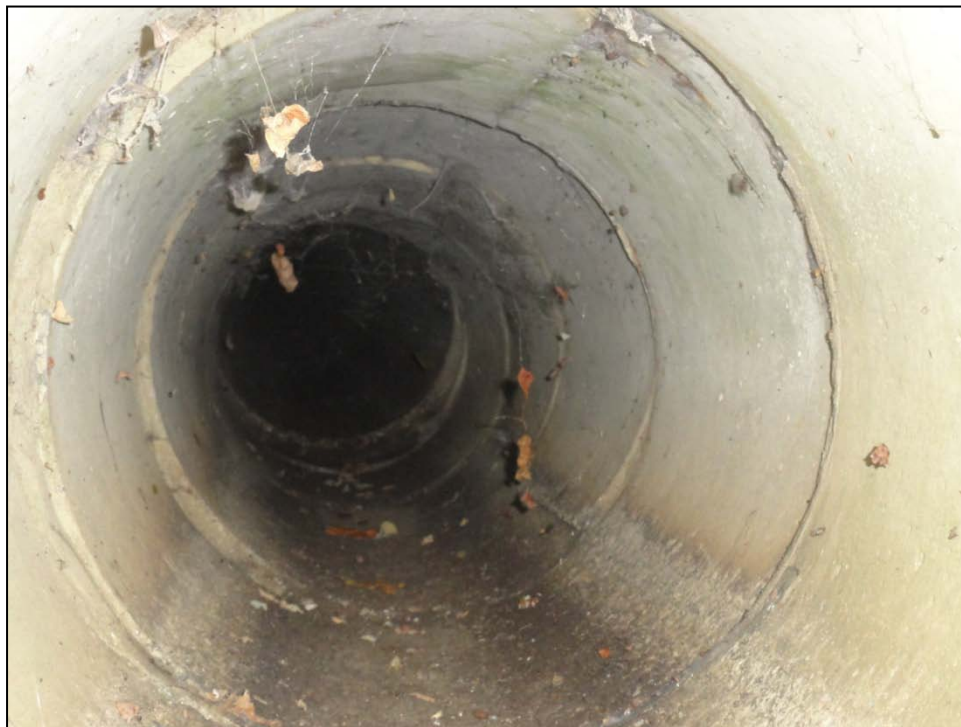
6. Inside of outlet conduit.

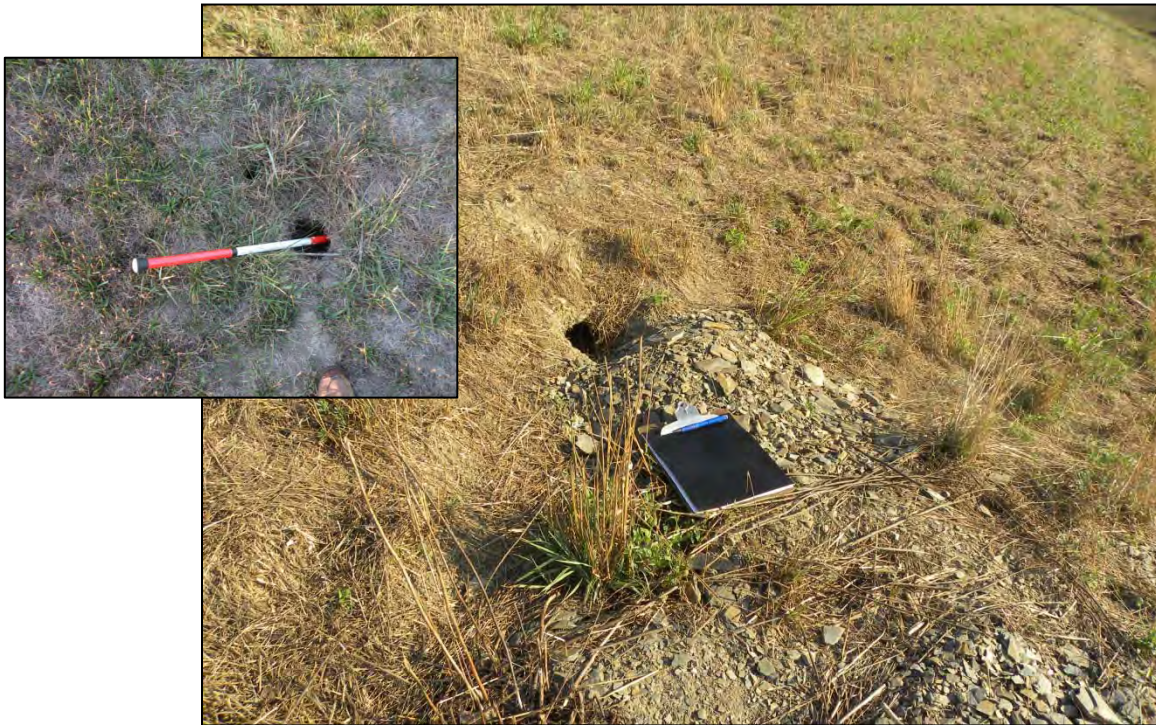
The grass cover on the upstream and downstream slope of the dam embankment appears to be adequate. There are, however, several large animal burrows located on both the upstream and the downstream slope of the dam embankment.

7. Animal burrows on both upstream and downstream slopes of the embankment.

11.1 Operations and Maintenance. Several maintenance deficiencies exist at New Creek Site 1 that need to be addressed. These include filling animal burrows, removal of obstructions in the auxiliary spillway, filling and reseeding the depression in the auxiliary spillway, removal of vegetation in the downstream discharge channel, and repairing the corroded lower trash rack.

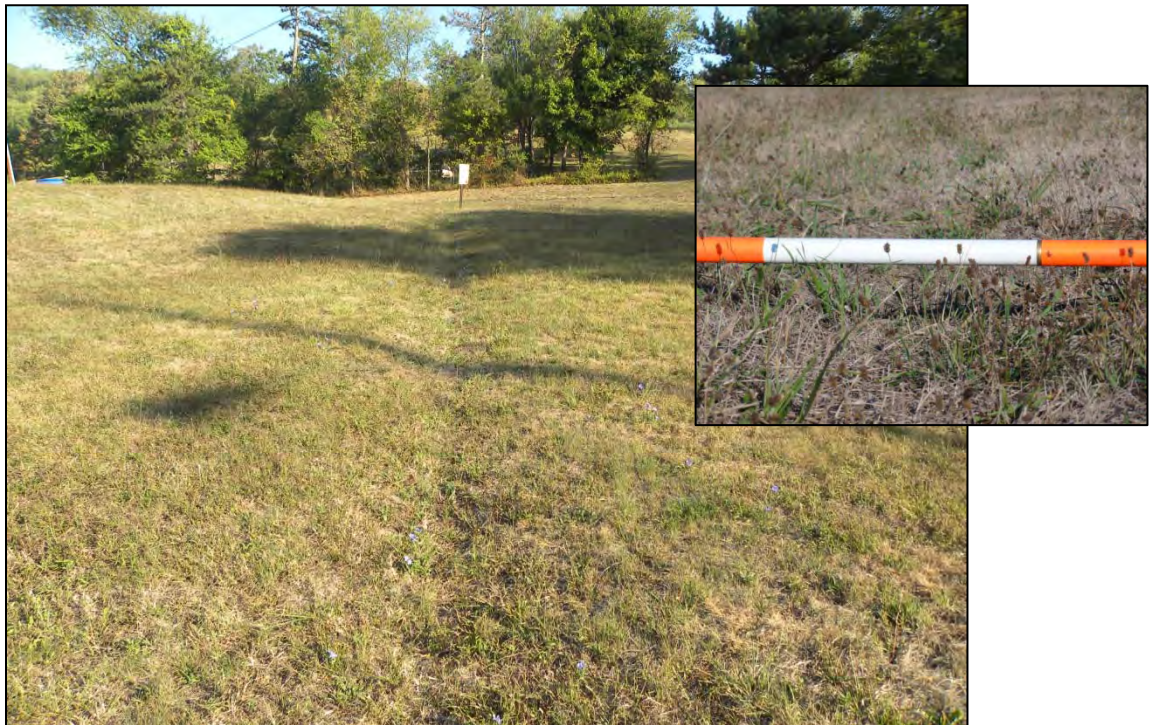
A residential water line has been installed through the auxiliary spillway. The backfill has since settled leaving a vegetated depression that extends through the channel of the spillway. Additionally, a small garden plot and fence was observed within the spillway channel. Many residential homes have been constructed immediately downstream of the auxiliary spillway and

Photo 8 in Appendix B shows a small depression that runs through the control section of the auxiliary spillway. This feature creates a preferential flow path and that can accelerate the erosion of the spillway. Photos 14 and 15 show other features observed during the site visit including several structures immediately downstream of the spillway and a small garden plot in the spillway that can also accelerate erosion of the spillway. These features have not been incorporated in the SITES auxiliary spillway analysis but should be considered in evaluating the overall integrity of the spillway. The SITES output for both the 6-hour and 24-hour storms for as-built, Class C criteria are presented in Appendix C. The electronic input files for the SITES model are furnished in the Supporting Data Folder on a CD.

8. Depression through auxiliary spillway due to installation of residential water line and settlement of backfill.

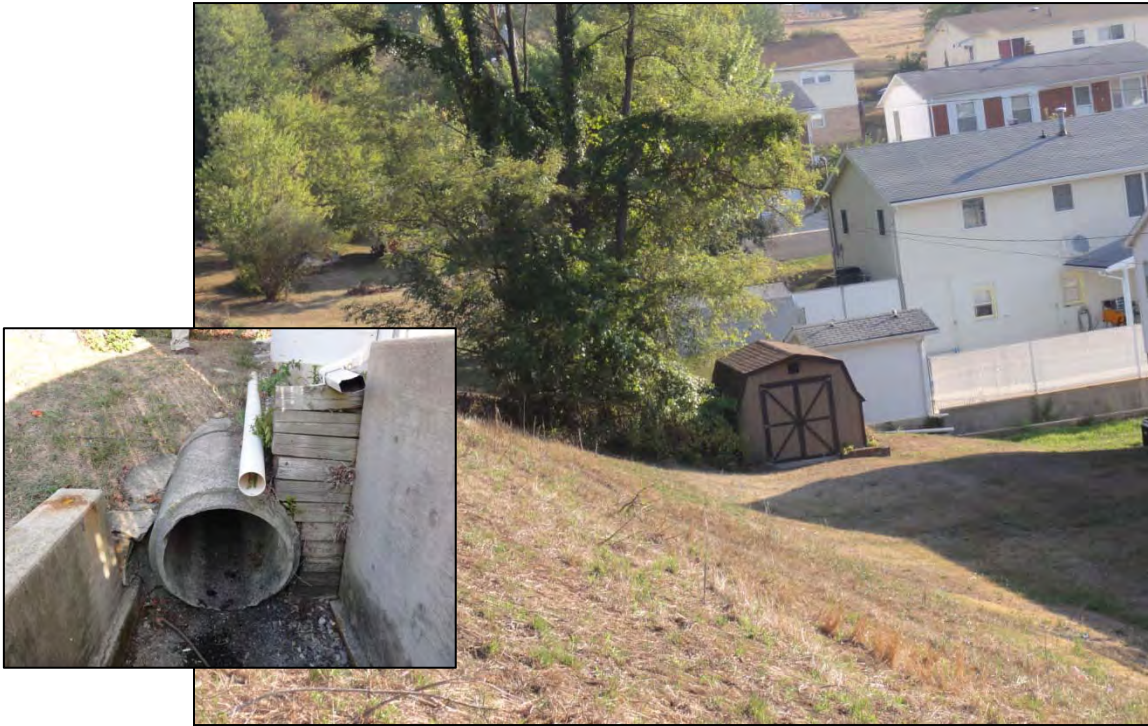
9. Principal spillway conduit outlet and discharge channel are encroached upon by large trees and residential structures.

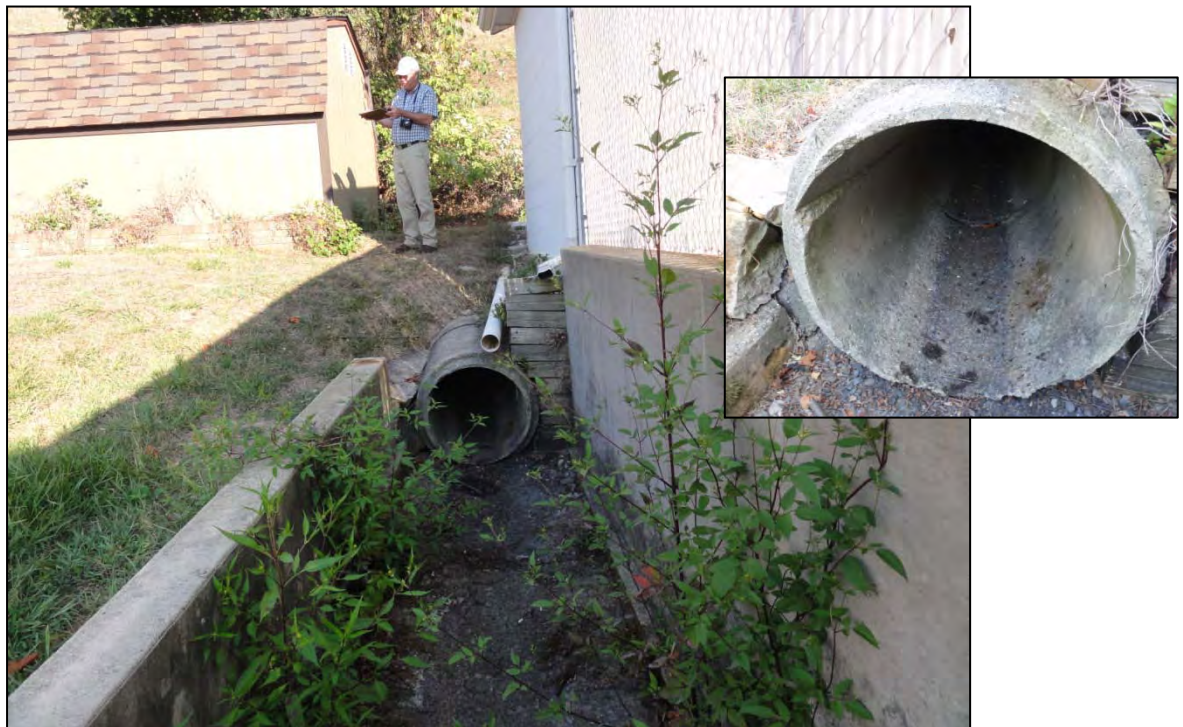
Significant modifications have been made to the principal spillway outlet and plunge pool as noted in SCS Trip Report dated March 5, 1984. The plunge pool has been completely backfilled and the principal spillway conduit extended to allow the construction of several structures immediately adjacent to the outlet. The conduit extension is significantly misaligned and damaged. A very large tree is also growing near the principal spillway conduit outlet and toe of the dam. No flow was entering the principal spillway intake at the time of inspection; however, a West Virginia Dam Safety Inspection Record dated November 12, 2009 indicated that principal spillway flows are passing thru a gap in the fifth joint from the outlet and draining to some unknown point downstream.

10. Principal spillway conduit has been extended and plunge pool replaced with discharge channel. The extension of the conduit is misaligned and significantly damaged near the outlet.

11.6 Rehabilitation Project. Significant modifications to the principal spillway outlet of New Creek Site 1 are needed to bring the dam into compliance with current NRCS high hazard dam design criteria, for the known deficiencies. This would include rehabilitation of the conduit, plunge pool or other method of energy dissipation, embankment drains, and the downstream discharge channel. A planning level total project cost to make structural modifications to the dam to meet current NRCS design criteria is estimated to be between \$1,500,000 and \$2,000,000. This estimate assumes that major expenditures to address potential embankment and auxiliary spillway integrity deficiencies are not required, as discussed in Section 9 and Section 11.2.

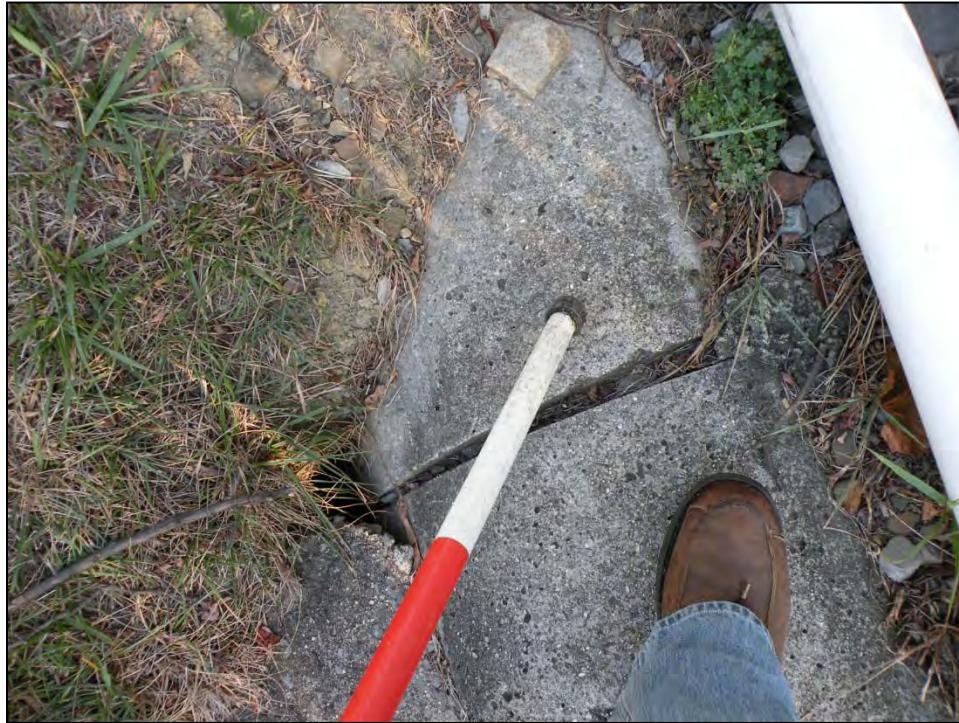
In addition to the site inspection, video inspection of the principal spillway conduit as provided by the NRCS was reviewed. The ROVER inspection of the principal spillway conduit was performed on September 17, 2002 and revealed joint separation and visible scouring of conduit bed material 18 feet from the conduit outlet as well as notable fractures and deterioration of the concrete lining up to 31 feet from the conduit outlet.

11. Joint separation and movement is evident at the outlet of the principal spillway conduit extension. Previous inspections have noted significant joint leakage.

As recommended by WV DEP, a thorough seepage assessment of the embankment should be performed and include televising the entire length of the conduit, and observing the conduit after each storm event that fills the pipe by about one quarter of its cross section. This seepage assessment should include a subsurface investigation to determine the geotechnical characteristics of the foundation and embankment.

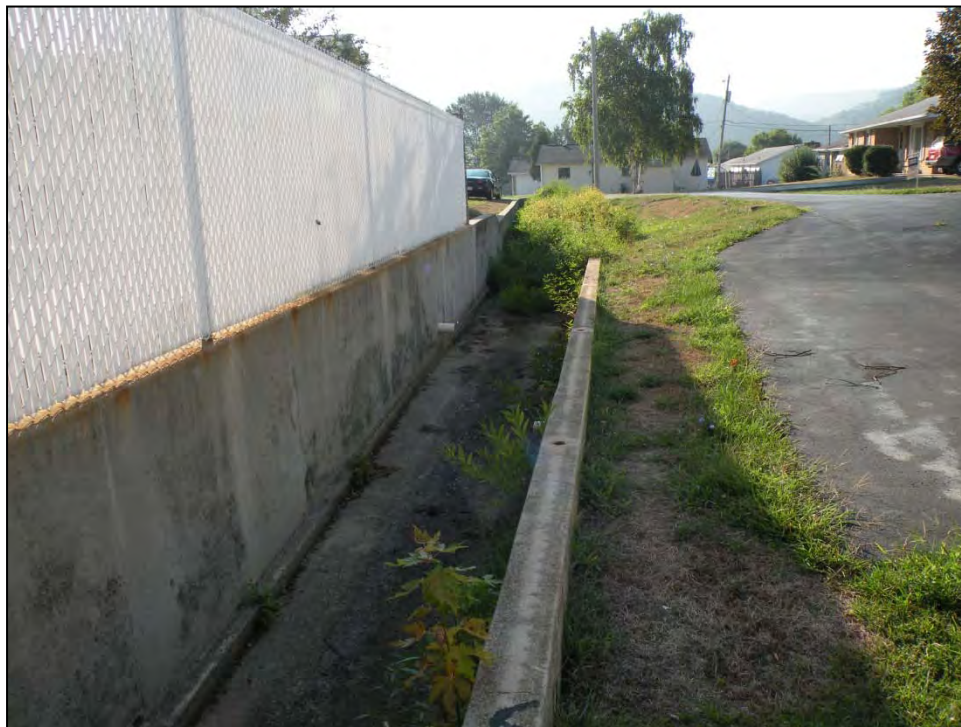
The outlet channel consists of a small, concrete-lined channel that is obstructed by vegetation and an undersized culvert just downstream of the outlet. No energy dissipation structure is in place. CMP drains shown on the as-built drawings have been buried. Their location and possible connection to more recent PVC drains near the conduit outlet is unknown. No signs of embankment instability or seepage were observed.

12. Vegetation and undersized culvert are obstructing the outlet channel of the principal spillway conduit.

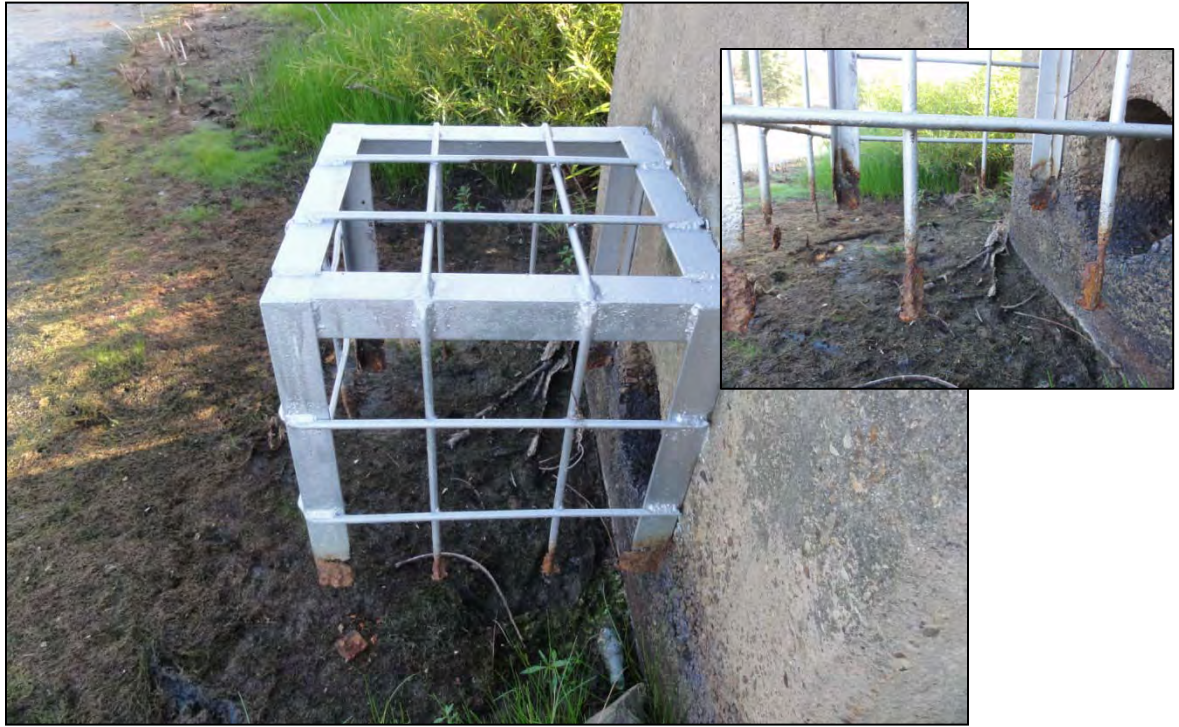
The bottom of the low inlet trash rack has corroded away and needs to be replaced. Otherwise, the concrete principal spillway riser structure appears to be in good condition and operating as designed. No external evidence of cracking or deterioration was observed.

13. Bottom of lower trash rack has completely corroded away

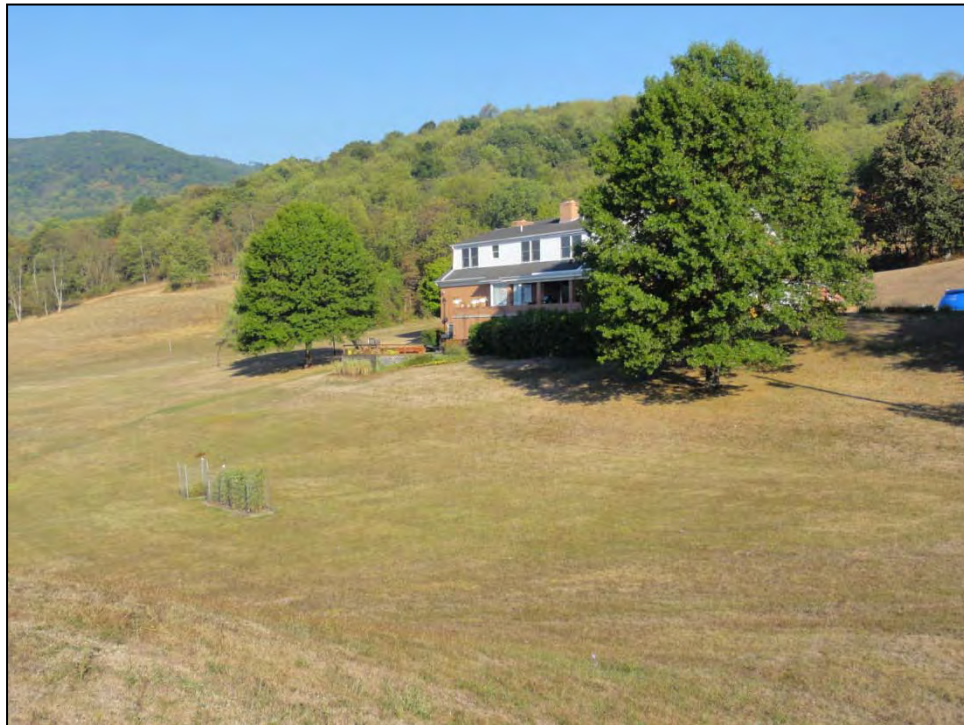
14. Small garden within the auxiliary spillway.

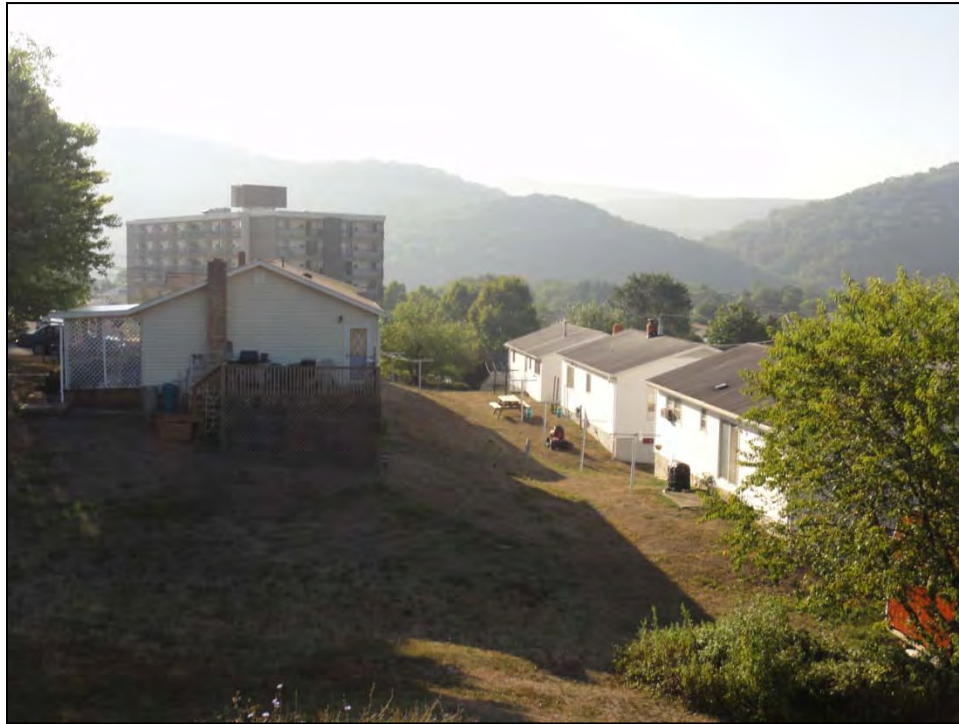
15. Residential homes and other structures located immediately downstream of the auxiliary spillway.

In addition to subsurface investigations, the potential for flooding at events less than the Probable Maximum Flood should be considered due to the development that has taken place immediately downstream of the dam. The Emergency Action Plan (EAP) should also be reviewed and updated accordingly since there are houses located just downstream of the auxiliary spillway. Current EAP guidelines call for evacuation of downstream persons only if the dam is in danger of failure; however, significant auxiliary spillway flows could endanger houses and potentially human life.

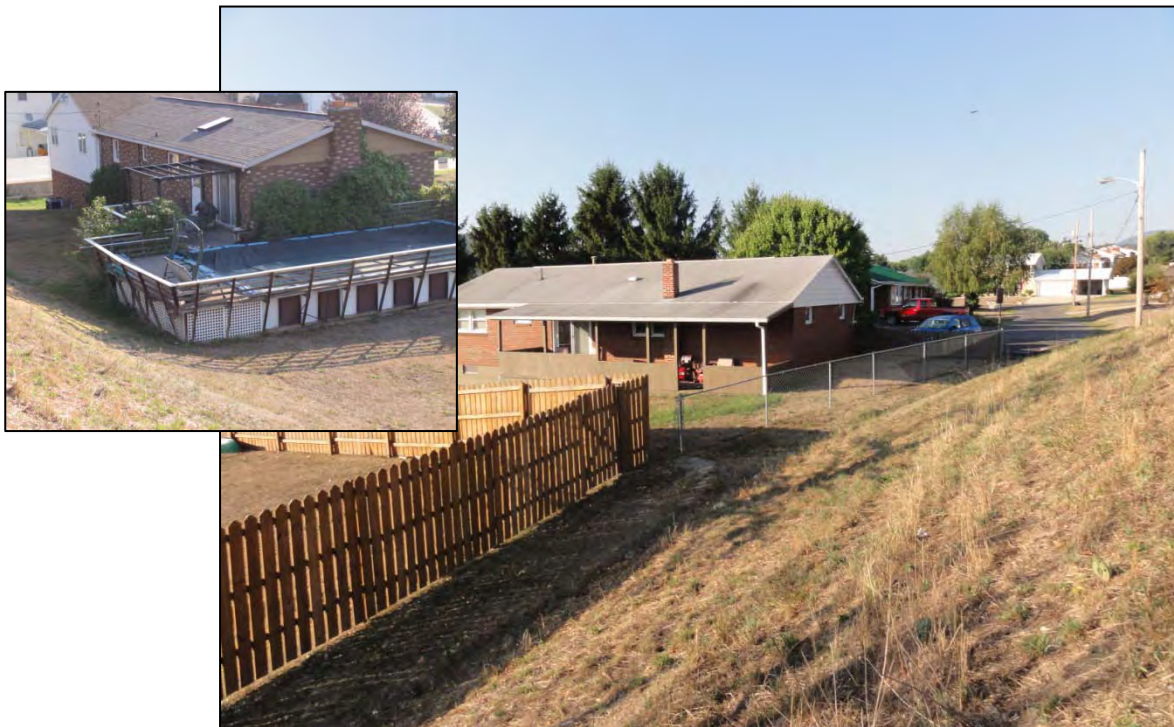
16. Residential homes and other structures encroaching on the toe of the dam.
