# NATURAL RESOURCES REPORT

## Identification, Delineation, and Assessment of Wetlands and Waterways Coal River Lock and Dam No. 3

**Coal River Lock and Dam No. 3**  
**Kanawha County, West Virginia**  
**GFT Project No. 084562**

**Capitol Conservation District**  
**Coal River Watershed Planning Study – Lock and Dam No. 3**  
**Kanawha County, West Virginia**

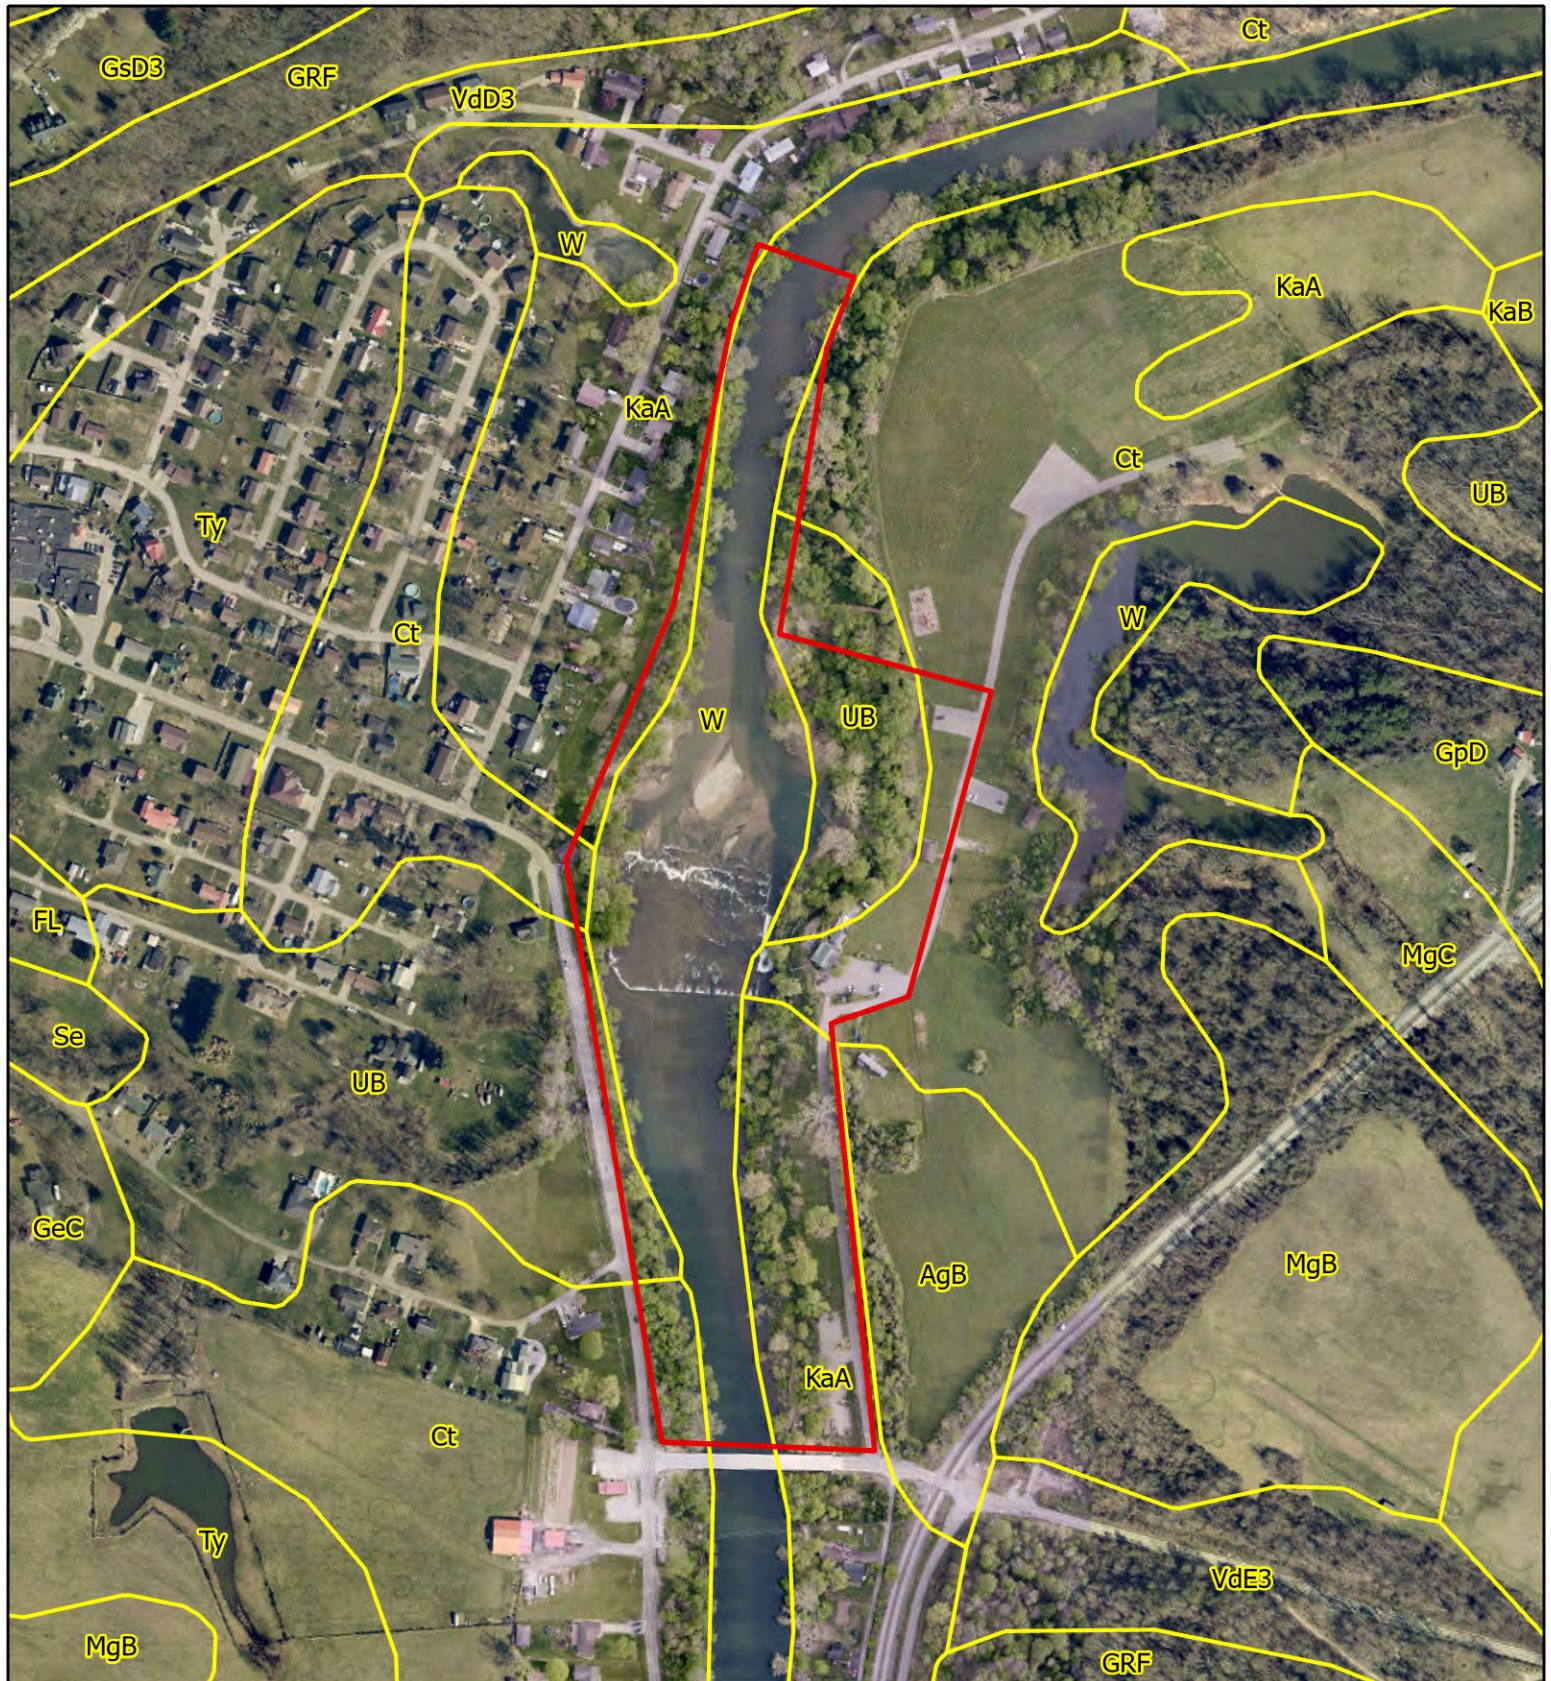
**Figure 3: Soils Map**

According to the U.S. Department of Agriculture (USDA), Natural Resources Conservation Service (NRCS) Web Soil Survey (2024), four (4) soil units were mapped within or immediately adjacent to the project study area (**Table 2**). The Soils Map for the project site is provided as **Figure 3**.

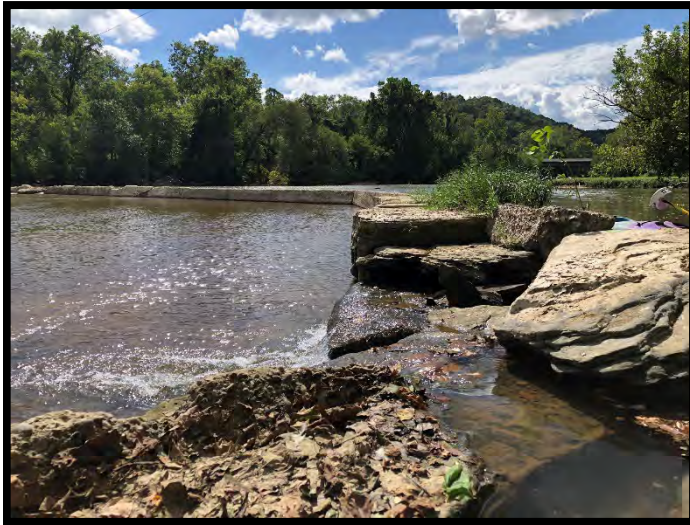
**Photo 1** (8-26-2025)

View of the dam looking upstream and southeast from the left bank. In the background, the Route 9 bridge and Vegetated Gravel Bar 1 are visible.

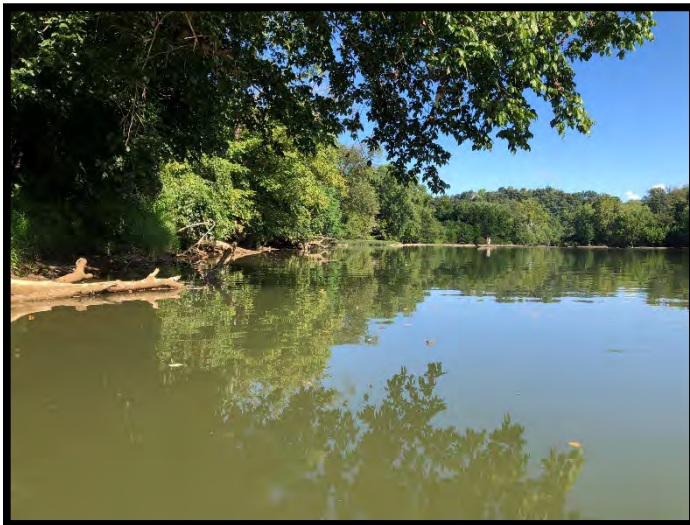
**Photo 2** (8-26-2025)

View of the pool impounded by the dam. View was downstream and north.

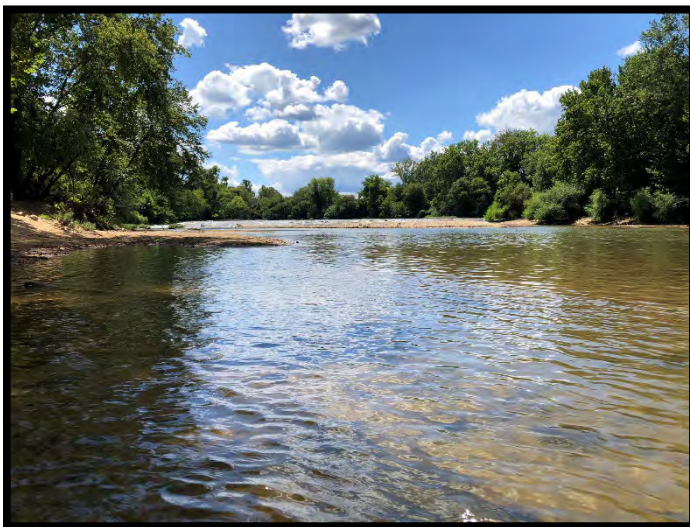
**Photo 3** (8-26-2025)

View of Coal River downstream of the dam looking upstream and south. The photo was taken within Coal River Sampling Reach 2.

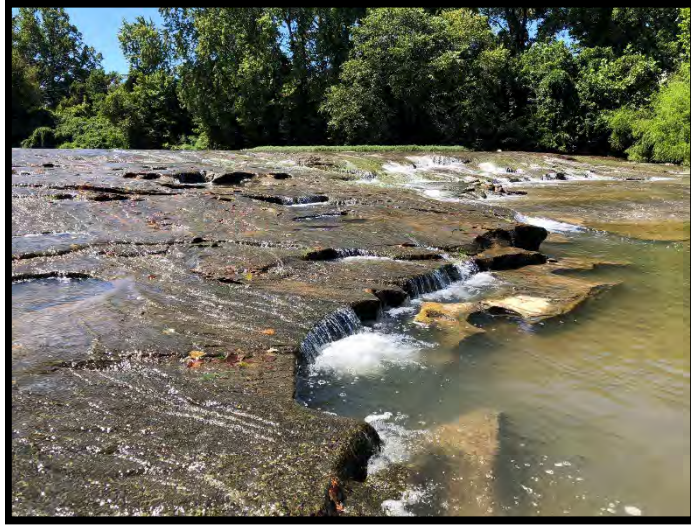
**Photo 4** (8-27-2025)

View of the natural bedrock falls immediately downstream of the dam. The falls are a popular recreational destination. Coal River Sampling Reach #3 was located within this section of the falls. View was upstream and southwest.

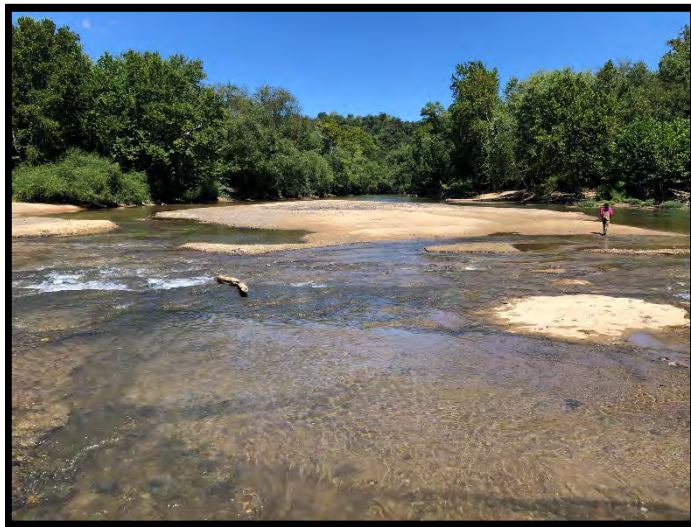
**Photo 5** (8-27-2025)

View sandbar development downstream of the falls. View was downstream and north.

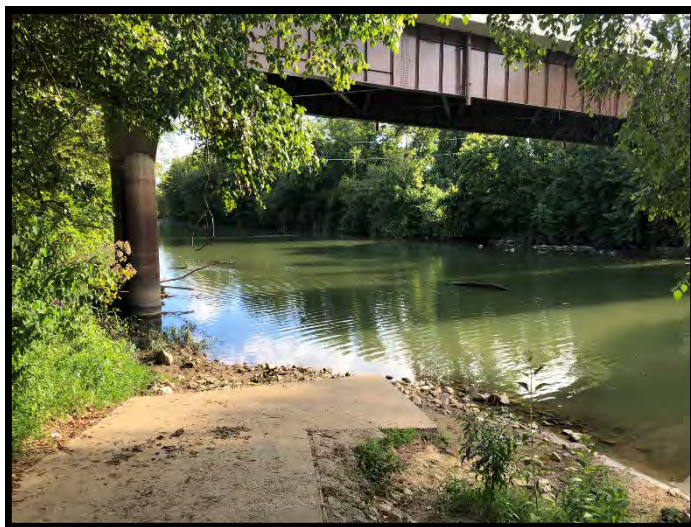
**Photo 6** (8-27-2025)

View of Coal River near the boat launch near the southern edge of the project study area. The launch and attached parking lot provide upstream access to the dam. View was upstream and southwest.

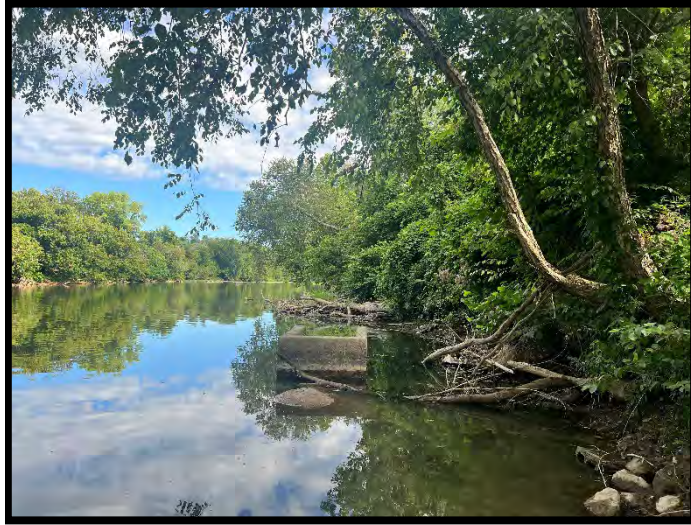
**Photo 7** (8-26-2025)

View of Coal River Sampling Reach 1 looking downstream and north. Sampling Reach 1 was within the impounded pool of the dam. Some large woody debris was observed along the banks of the sampling reach.

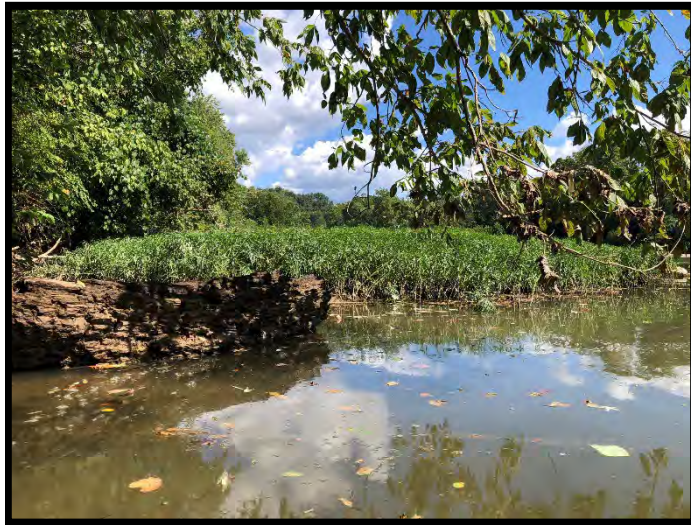
**Photo 8** (8-27-2025)

Two (2) vegetated bars composed of sandy/gravelly substrate and populated with water willows were observed within the bed and banks of Coal River. These features are considered temporary and are likely seasonal and do not contain persistent characteristics of wetlands and are considered part of the habitat variability of Coal River.

View of Vegetative Bar 1 in Coal River looking downstream and north.

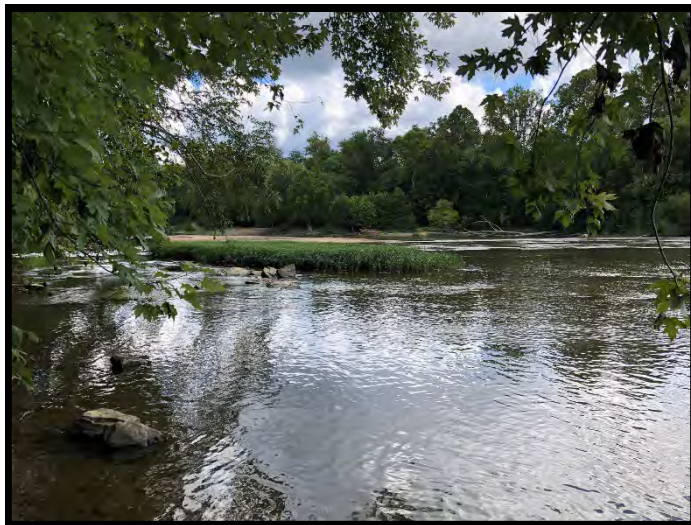
**Photo 9** (8-27-2025)

View of Vegetative Bar 2 in Coal River looking downstream and northeast.

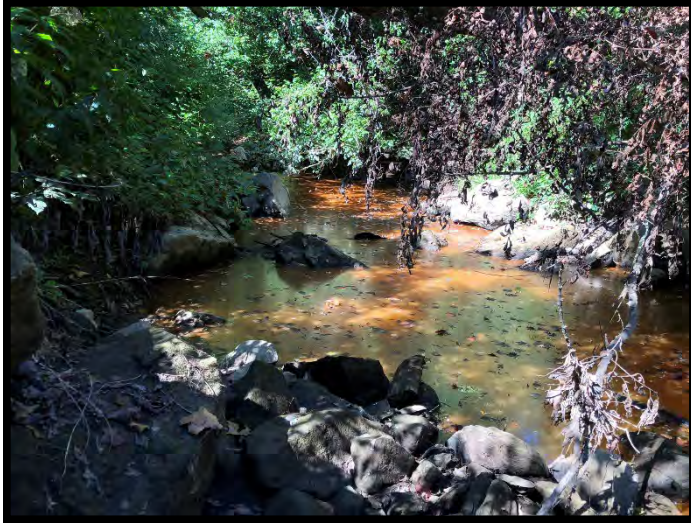
**Photo 10** (8-27-2025)

Stream 1 (Falls Creek): Stream 1 was confirmed as a perennial tributary to Coal River. Stream 1 continues upstream beyond the limits of the project study area. Unlike Coal River, the substrate of Stream 1 was composed primarily of cobbles and boulders. Stream habitats included riffle, run, and pools. Obvious pollution sources were noted, including metal scraps, iron staining, and unpleasant odors. Riparian vegetation included elderberry, silver maple, and river birch.

View of Stream 1 (Falls Creek) looking upstream and southwest from the upstream edge of the delineated reach. Obvious signs of pollution were visible, including the presence of metal scraps and iron staining.

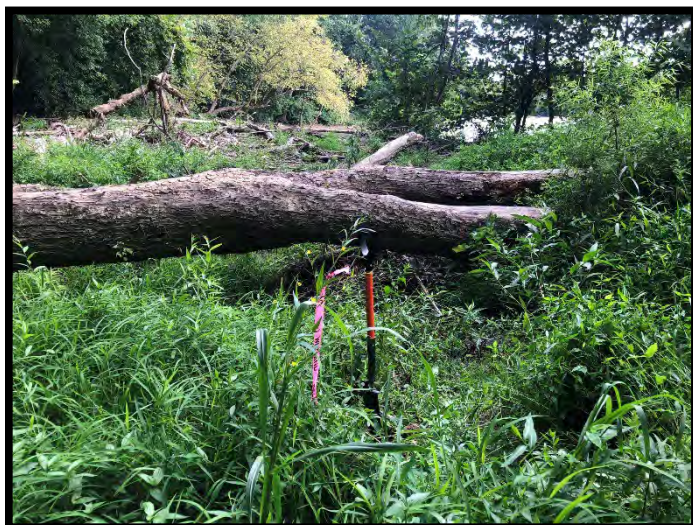
**Photo 13** (8-26-2025)

View of the PEM portion of Wetland 1. The hydric test plot (W1-HYD1) is visible in the foreground. View was south.

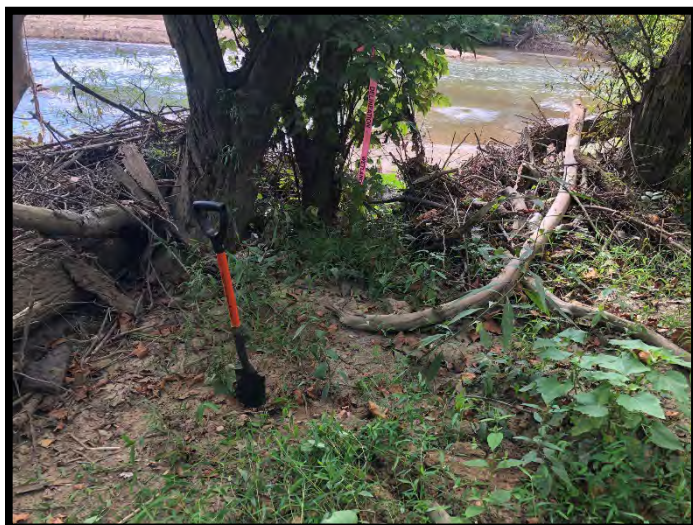
**Photo 14** (8-26-2025)

Wetland 1: Wetland 1 (PEM/PFO) was located downstream of the Coal River Dam in an area of accumulated sediments at the toe of slope of the streambank. This area is highly disturbed by flooding and human recreation. It is a very popular site to access the natural falls, and a variety of trash was observed within the wetland. The PEM portion of the wetland was located in a shallow depression at the toe of slope, and the PFO portion was along the stream edge. Wetland 1 was 0.368 acres, with PEM portion being 0.230 acres and PFO portion being 0.138 acres. No wildlife was observed within the wetlands during the field investigation.

View of the hydric test pit for the PFO portion of Wetland 1. This portion of the wetland was highly disturbed from flooding and human recreation. Large piles of woody debris, trash, and sediment accumulation were observed. View was northwest.

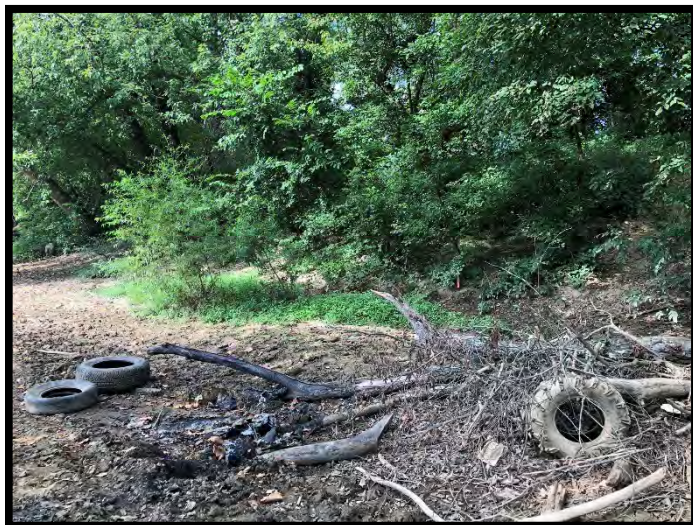
**Photo 15** (8-26-2025)

View of accumulated trash and a fire pit in Wetland 1. Human disturbance and flooding caused sparse vegetation in some areas, as shown. View was northeast.

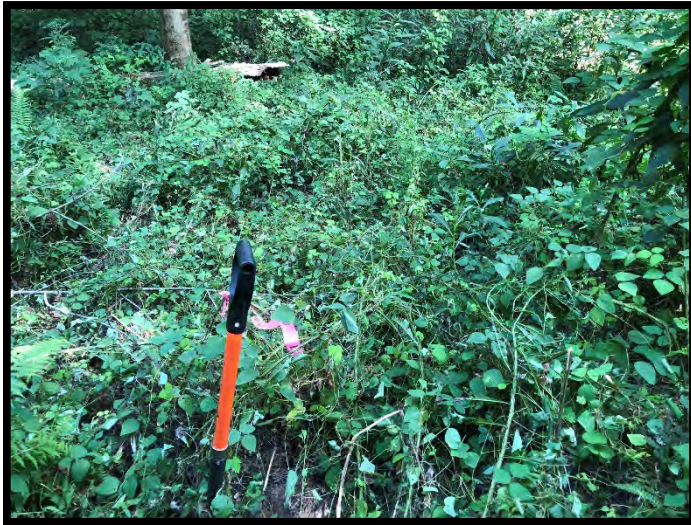
**Photo 16** (8-26-2025)

View of upland test pit UPL-A. UPL-A was located in a mapped NWI wetland, but hydric soils were not observed and vegetation did not pass the dominance/prevalence tests. View was east.

Remarks:  
UPL-A was a test pit taken in a floodplain terrace uphill of Wetland 1 in a mapped NWI wetland (PFO). Some hydrophytes were present, but the prevalence/dominance tests were not met, and soils were not hydric. Some weak hydrology was observed, including surface soil cracks and the geomorphic position of the floodplain terrace at the toe of slope.

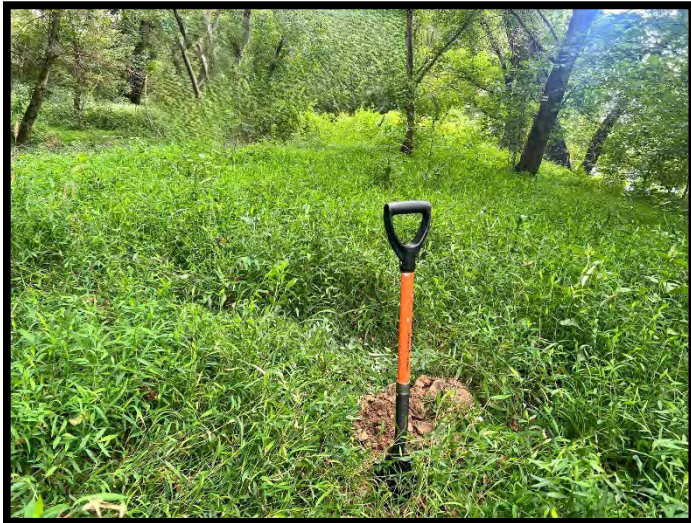
**Photo 17** (8-26-2025)

View of upland test pit W1-UPL, which was located uphill of Wetland 1 on a floodplain terrace. View was south.

Remarks:  
No primary or secondary wetland hydrology indicators were observed.

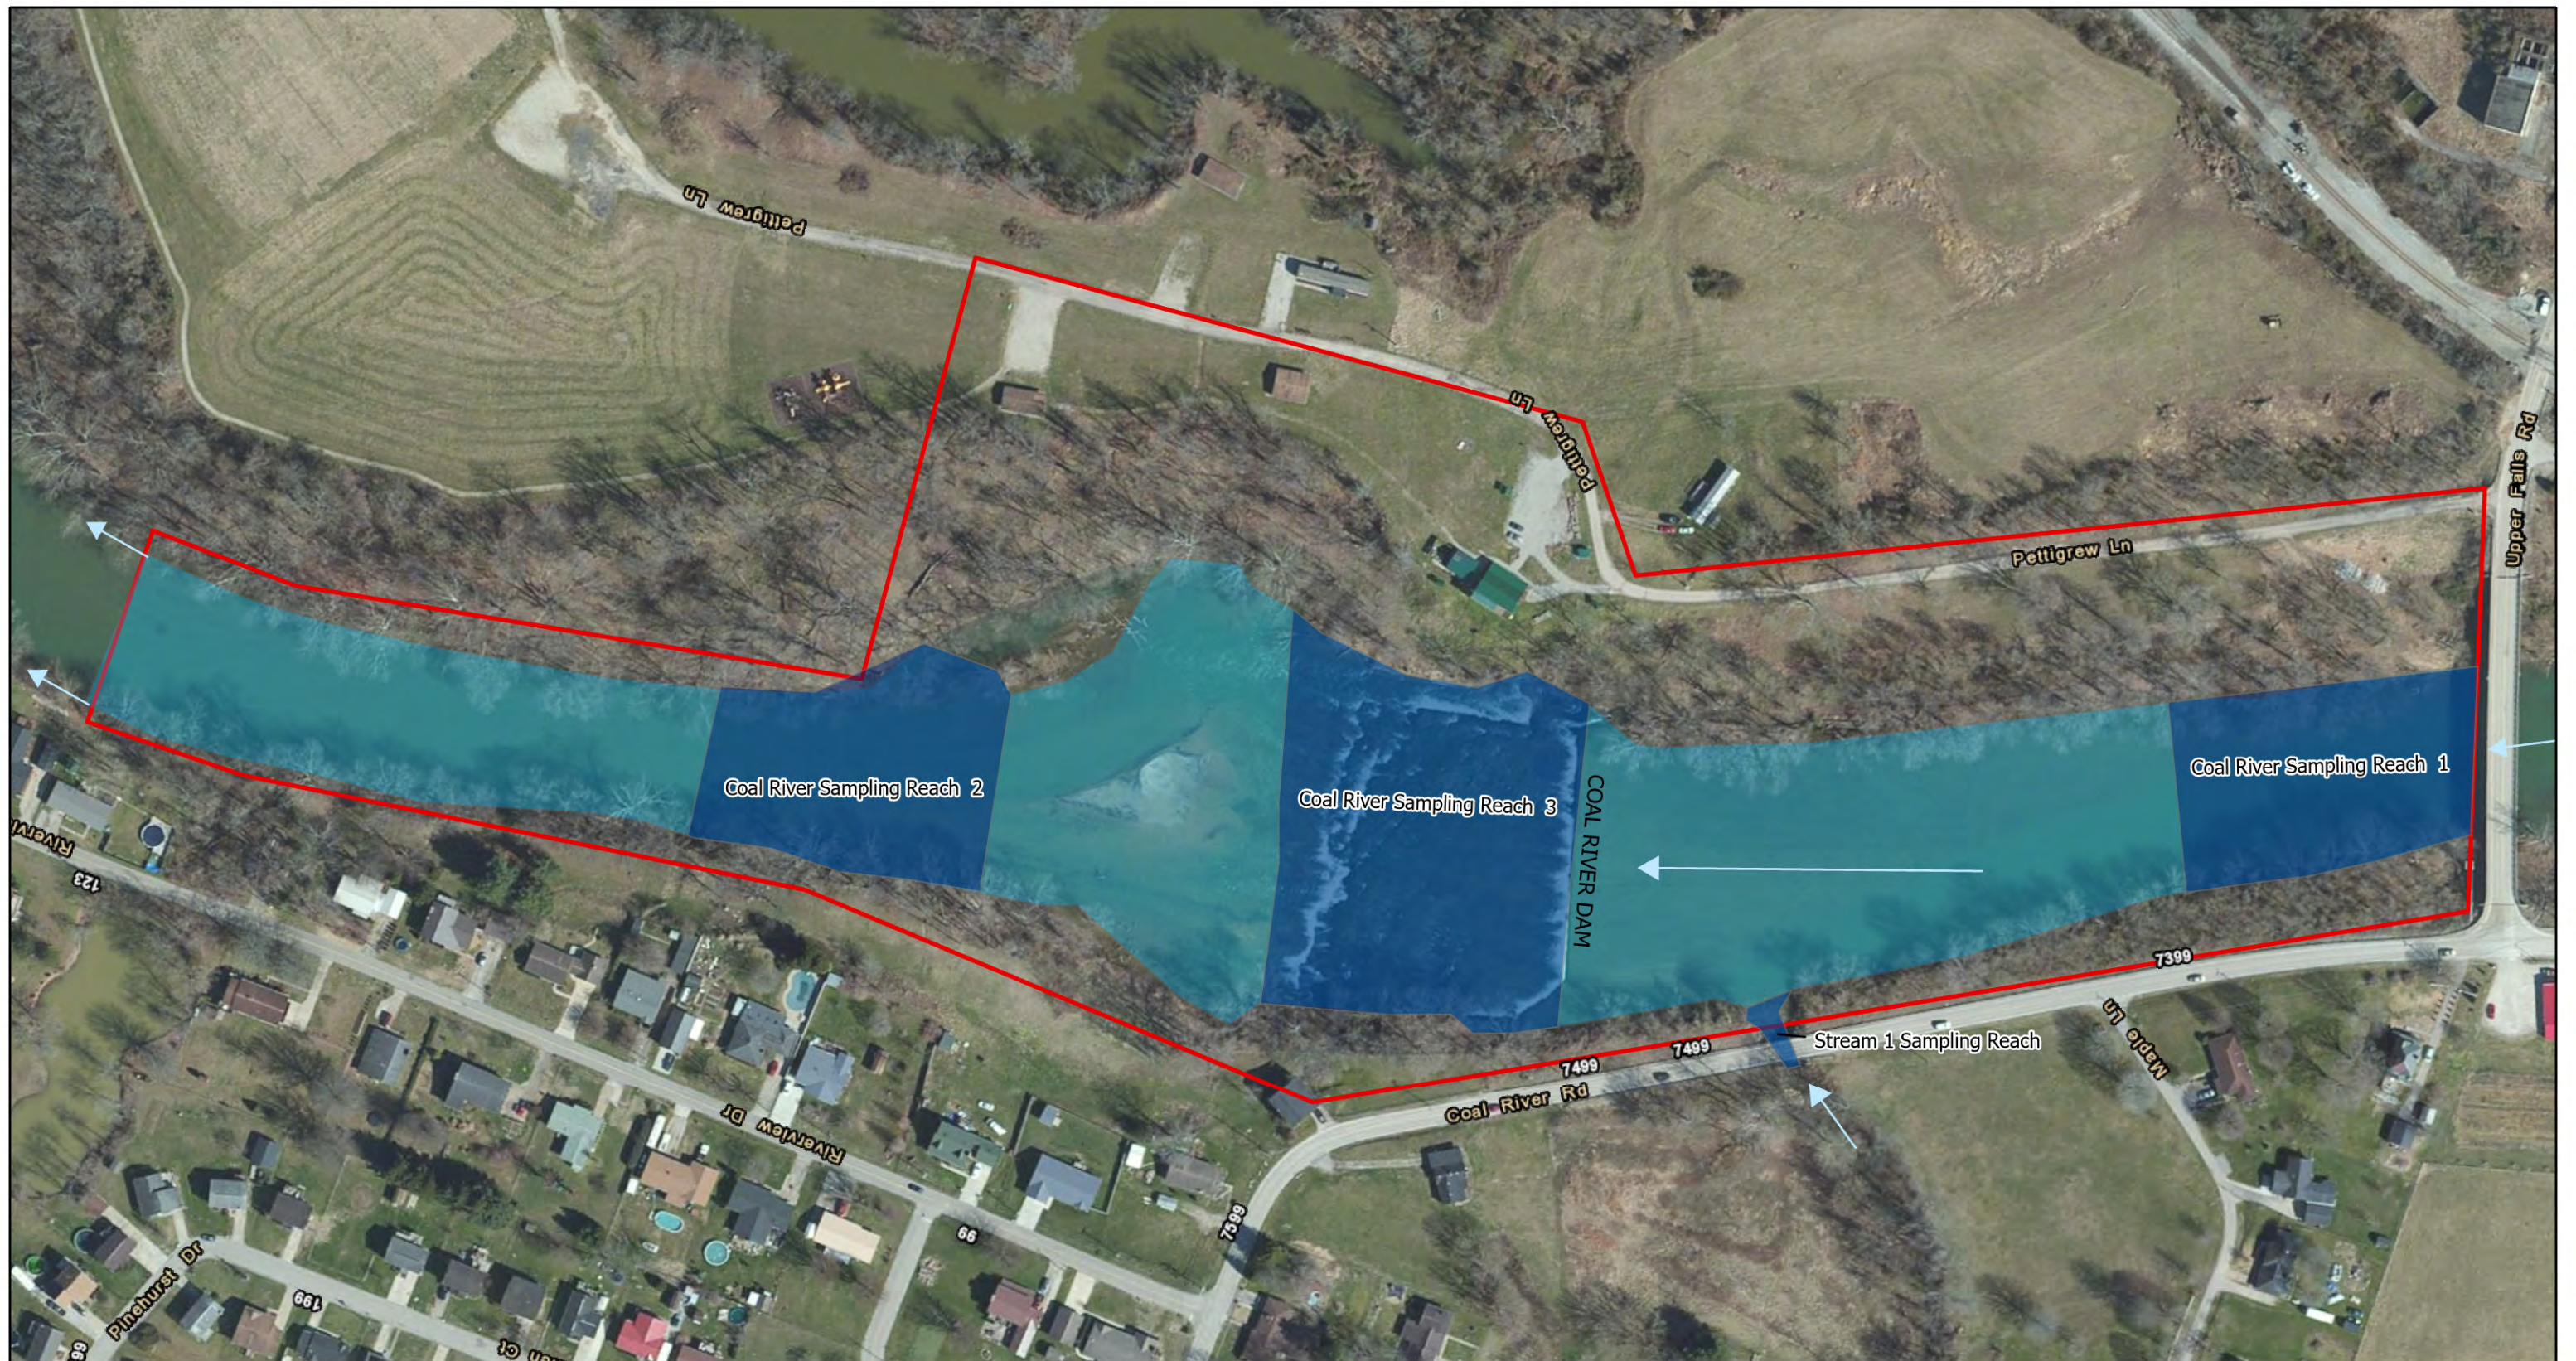
### Stream Assessment Reach Map

- Project Study Area
- Stream
- Sampling Reach
