REHABILITATION ASSESSMENT REPORT

New Creek Watershed Site 1

Mineral County, West Virginia

March 2011

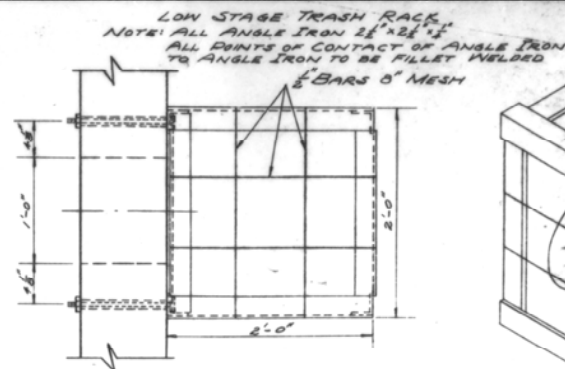
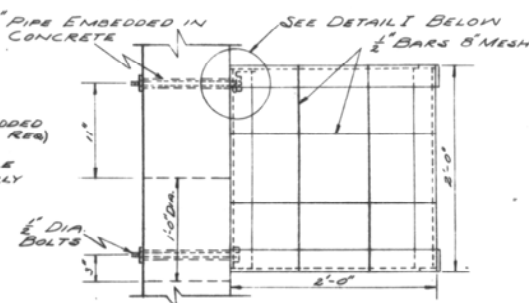
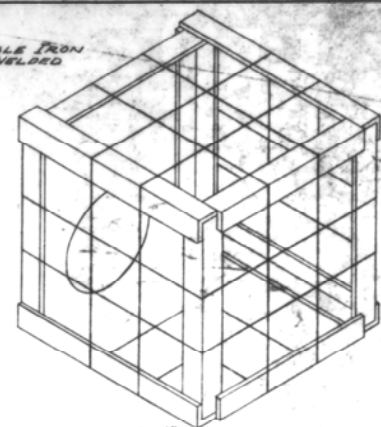
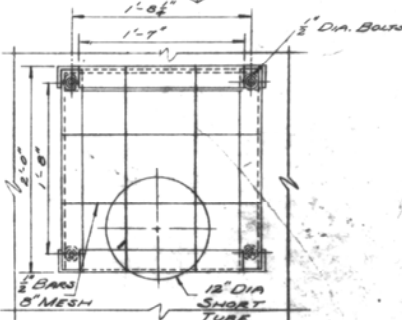
LOW STAGE INLET TRASH RACK (1 REQUIRED)

The bottom of the low inlet trash rack has corroded away and needs to be replaced. Otherwise, the concrete principal spillway riser structure appears to be in good condition and operating as designed. No external evidence of cracking or deterioration was observed.
